# Inspection Report

**Baker Inspections**

## Property Address

10892 Monticello  
Pinckney, MI

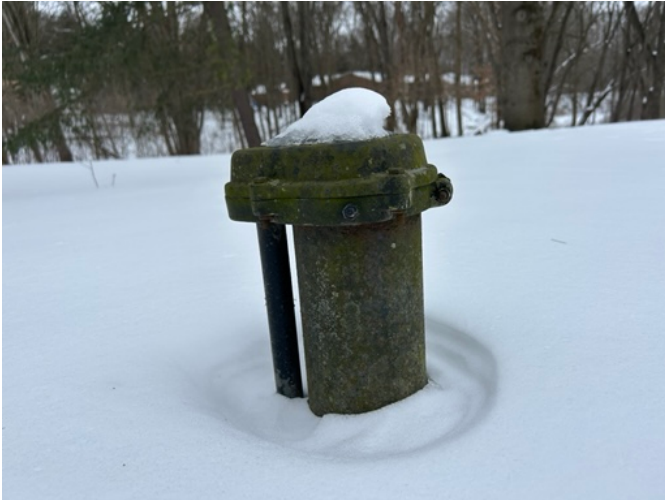
#### 1.1) Locate Well

4 inch steel

Submersible

40- -60 short cycle

10 GPM

Turned on the water inside the house for the duration of the inspection. The well sustained average pressure and volume throughout the house. The pressure tank is short cycling and should be replaced. The well and the well equipment appear to be functioning properly at the time of inspection.

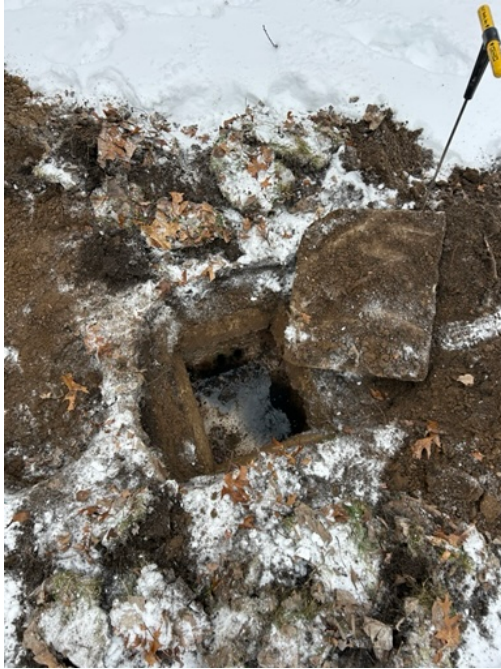
#### 2.1) Locate Septic Tank(s)

Yes

No

Located and dug up the septic tank. The septic tank has a thick scum layer and should be pumped out. Located in dug one test hole in the drainfield. The drainfield has clean stone and dry sand. Due to the frost, the rest of the drainfield could not be located/excavated. The septic system appears to be functioning properly at the time of inspection.

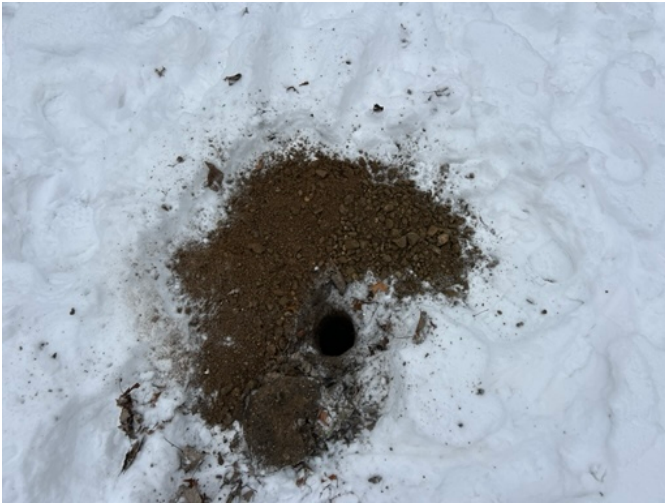
#### 2.7) Dig Holes in Drainfield

One test hole
